RESTORATION PLAN DRY CREEK BRIDGE REPLACEMENT PROJECT TOLLHOUSE, FRESNO COUNTY, CA

Project No. 2738-01

REVEGETATION PLAN DRY CREEK BRIDGE REPLACEMENT PROJECT TOLLHOUSE, FRESNO COUNTY, CA

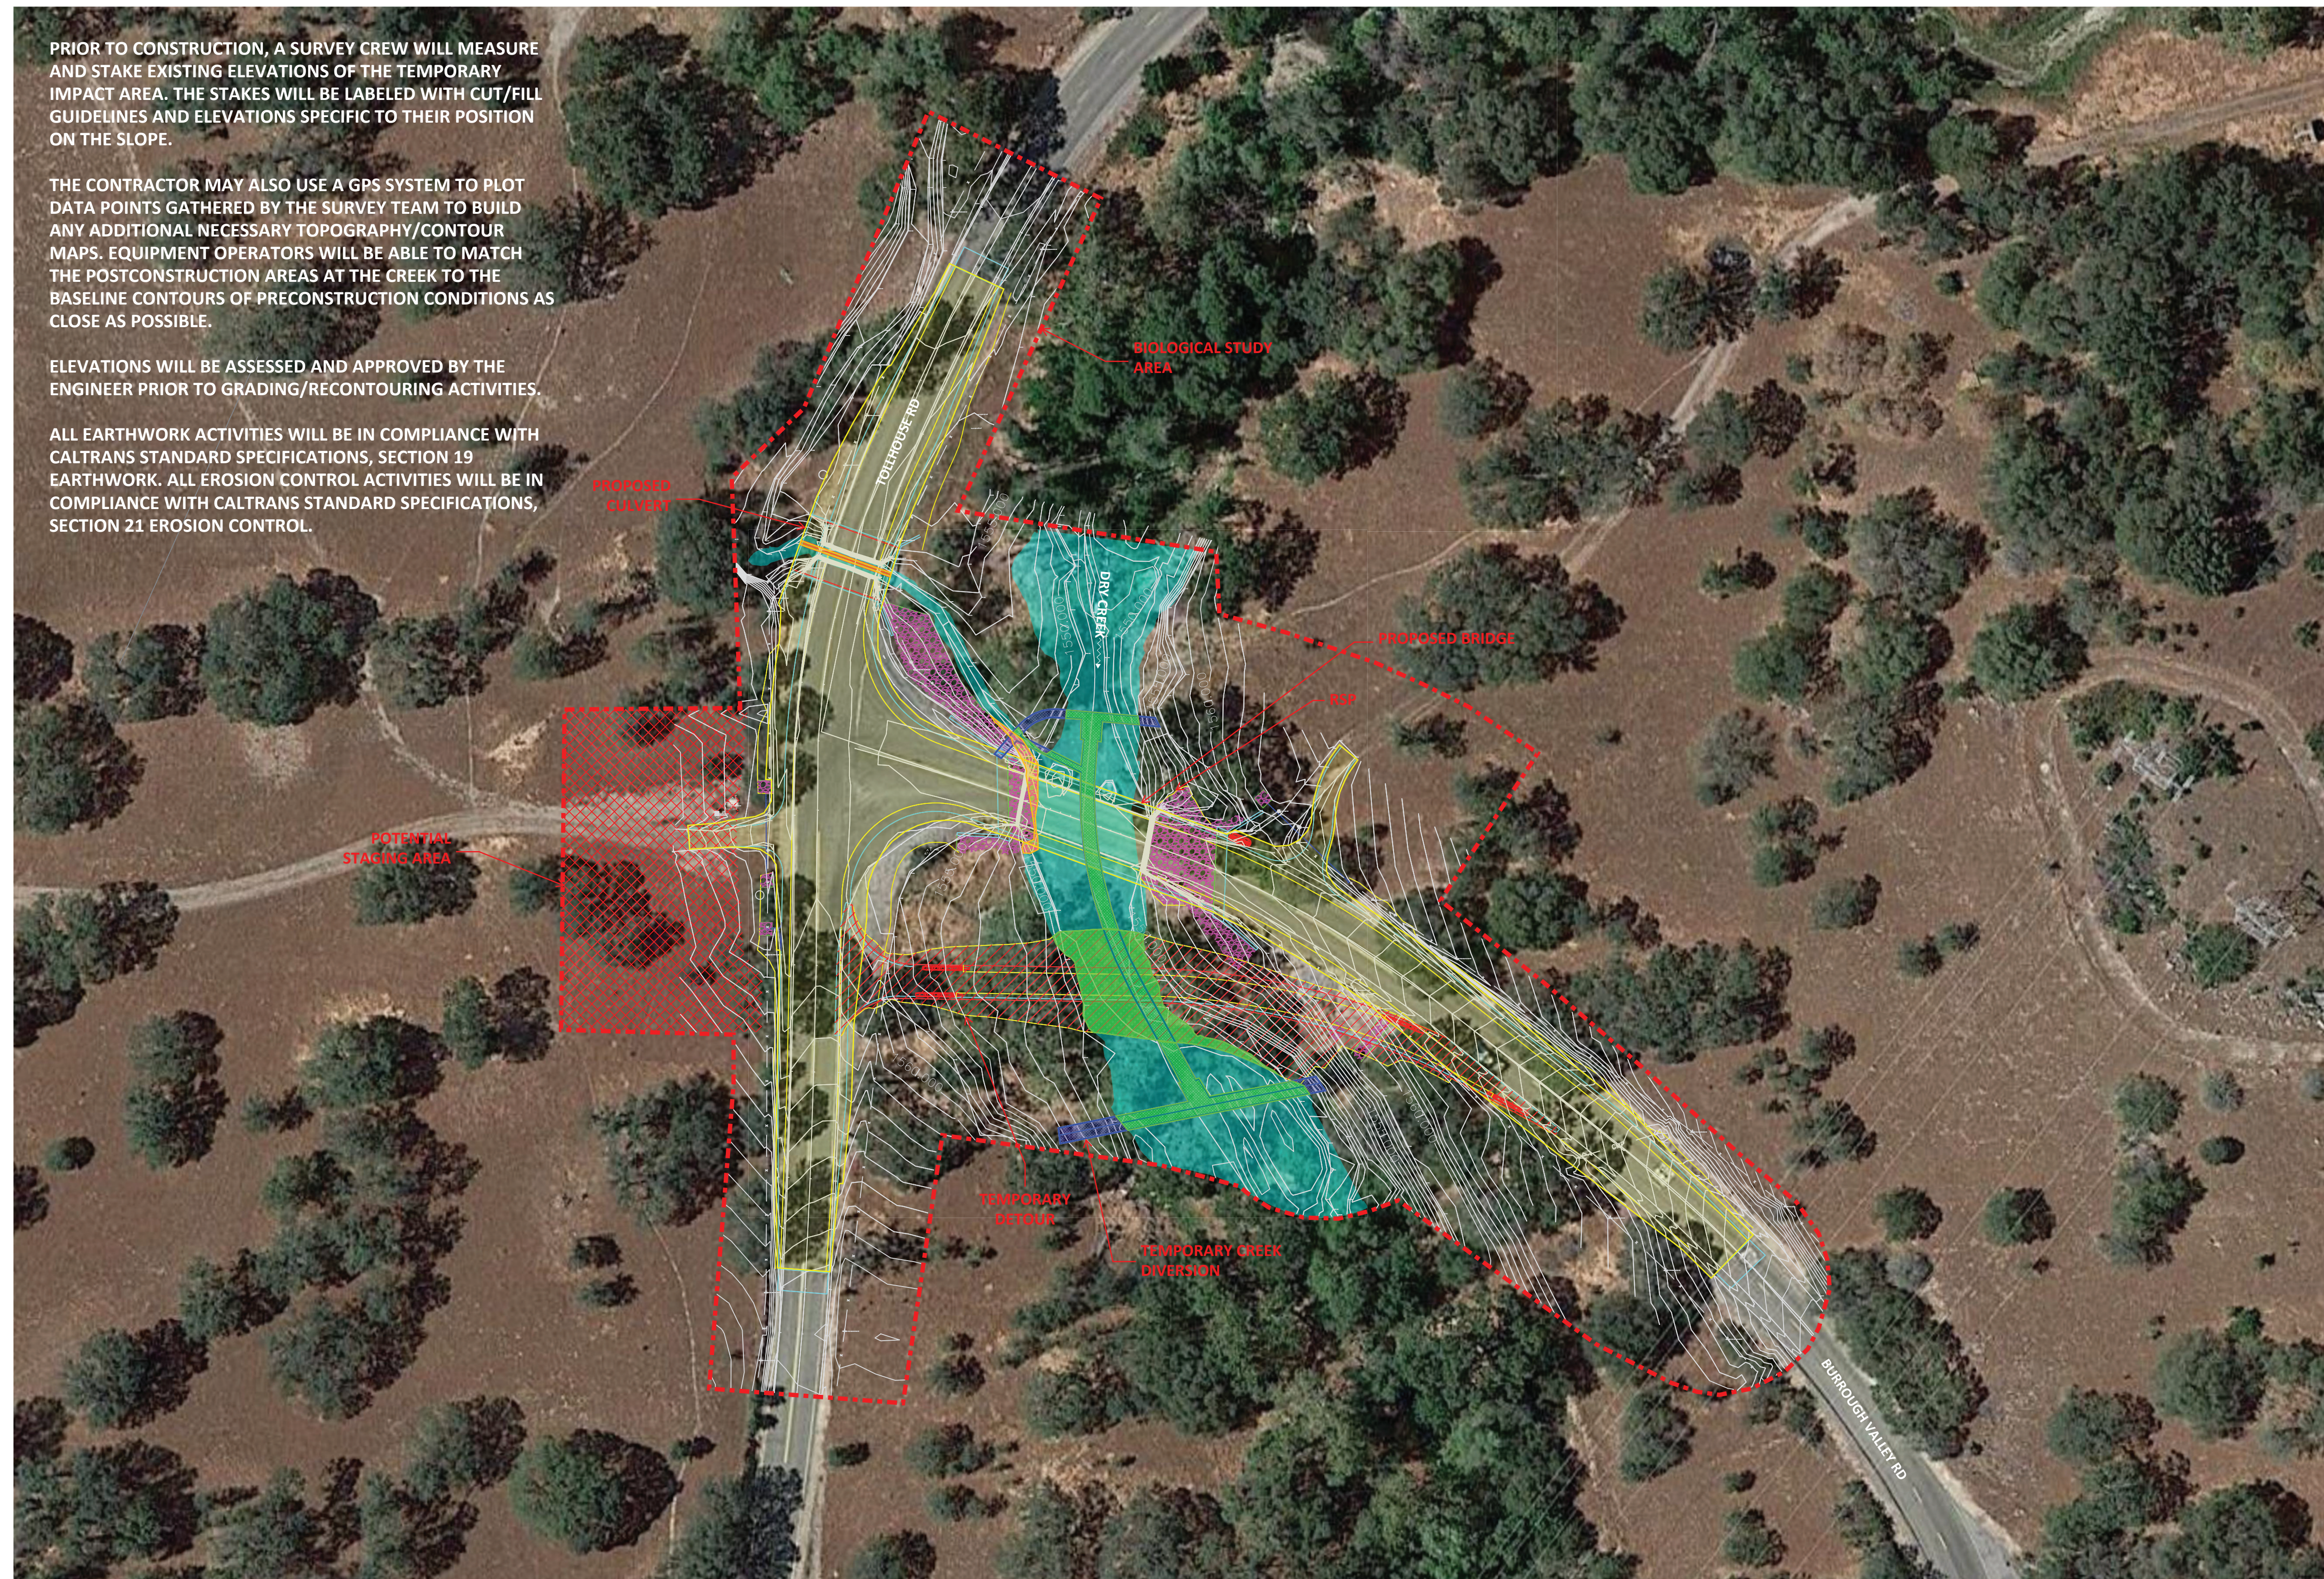
THE CONTRACTOR MAY ALSO USE A GPS SYSTEM TO PLOT DATA POINTS GATHERED BY THE SURVEY TEAM TO BUILD ANY ADDITIONAL NECESSARY TOPOGRAPHY/CONTOUR MAPS. EQUIPMENT OPERATORS WILL BE ABLE TO MATCH THE POSTCONSTRUCTION AREAS AT THE CREEK TO THE BASELINE CONTOURS OF PRECONSTRUCTION CONDITIONS AS CLOSE AS POSSIBLE.

ELEVATIONS WILL BE ASSESSED AND APPROVED BY THE ENGINEER PRIOR TO GRADING/RECONTOURING ACTIVITIES.

ALL EARTHWORK ACTIVITIES WILL BE IN COMPLIANCE WITH CALTRANS STANDARD SPECIFICATIONS, SECTION 19 EARTHWORK. ALL EROSION CONTROL ACTIVITIES WILL BE IN COMPLIANCE WITH CALTRANS STANDARD SPECIFICATIONS, SECTION 21 EROSION CONTROL.

A grading plan has been developed based on preconstruction conditions documented by the County's survey crew (see Appendix B: Grading Plan). Prior to construction, a survey crew will measure and map existing elevations of the temporary impact area. The area will be staked to mark where the known elevations are. The stakes will be labeled with cut/fill guidelines and elevations specific to their position on the slope.

The Contractor may also use a GPS system to plot the data points gathered by the survey team to build additional topography maps. By using the maps and following the staking, equipment operators will be able to match the postconstruction grade to the baseline contours of preconstruction conditions as close as possible.
