County of Fresno

Subject: Response to Incomplete Notification Letter on April 17, 2019
Notification No. 1600-2019-0068-R4
Lost Lake Nature Trail San Joaquin River – County of Fresno

LOST LAKE NATURE TRAIL
 LENGTH OF PROJECT - 0.35 MILES
100% DESIGN PHASE

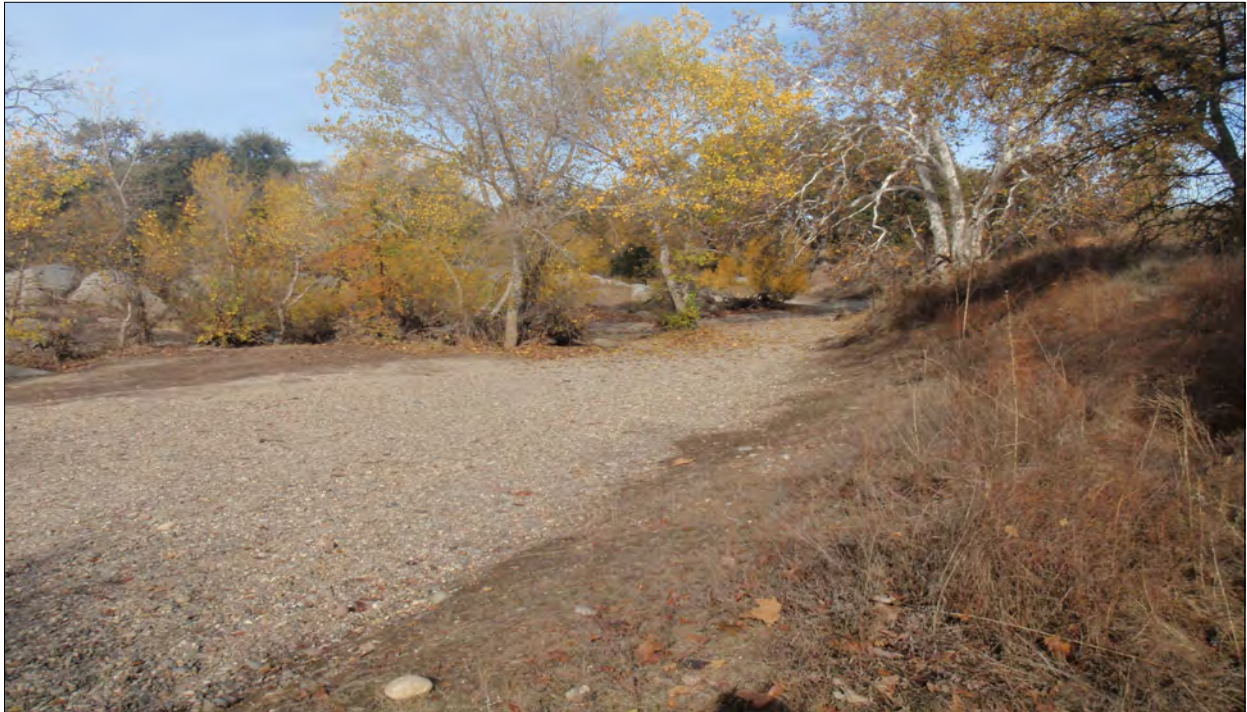
Figure 4. Photograph of the Lost Lake Trail, facing north, showing water marks along the embankment and gravel deposits along the trail.

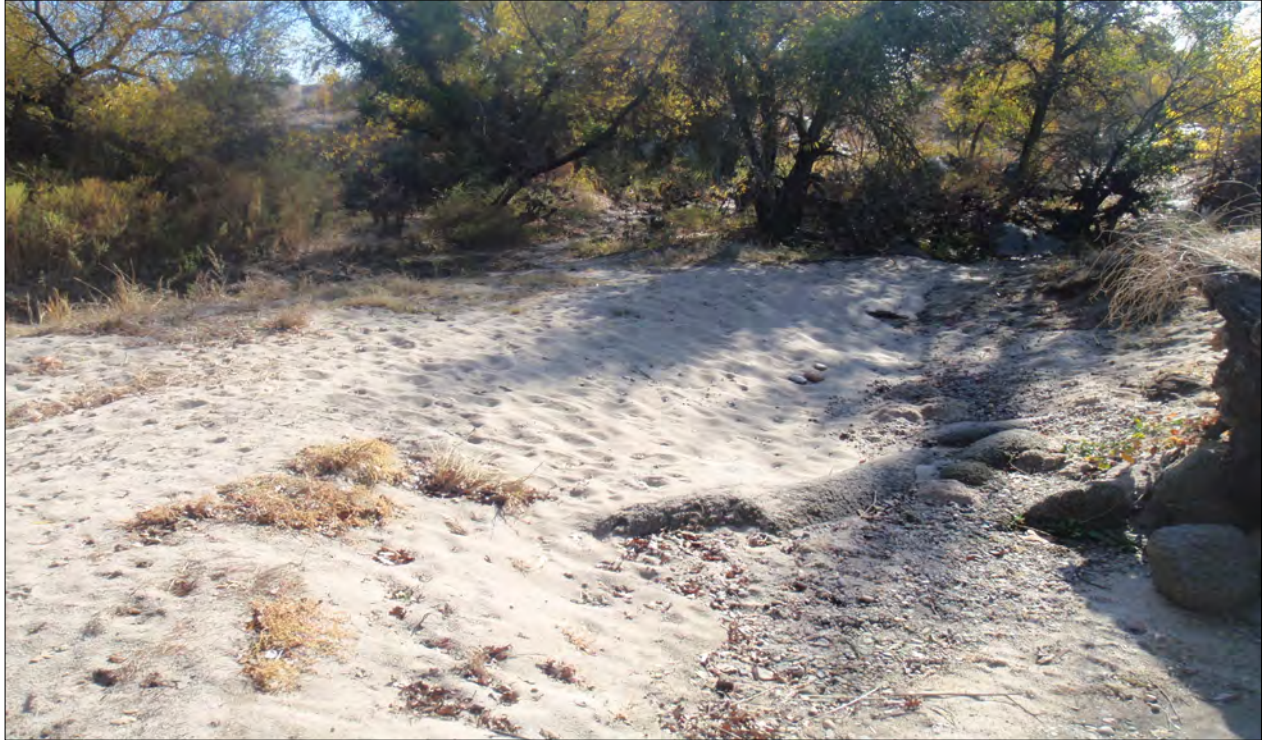
Figure 5. Photograph of Lost Lake Trail, looking southeast, showing fine sediment deposits from inundation.

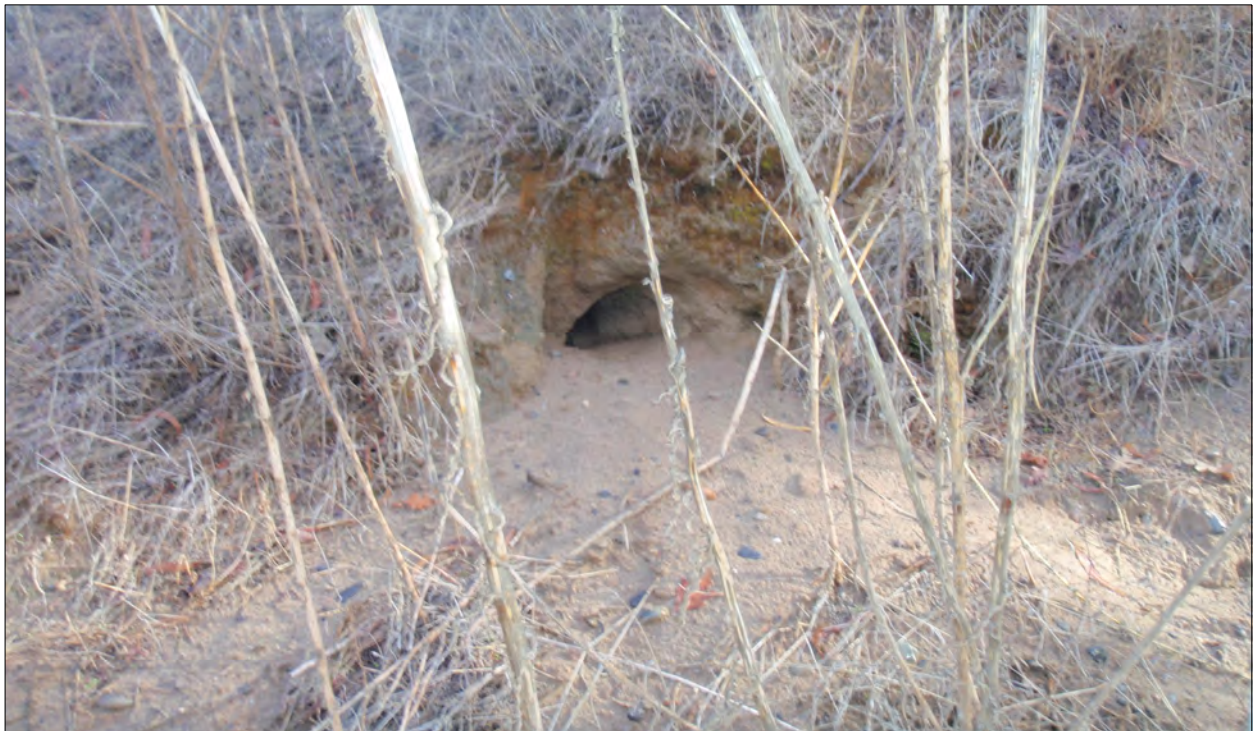
Figure 6. Photograph of a California ground squirrel burrow on a slope east of Lost Lake Trail in the biological survey area.

Four California ground squirrel (*Otospermophilus beecheyi*) burrows were found within the biological survey area on a steep, vegetated slope east of Lost Lake Trail (Figures 1 and 6). These burrows, plus four additional small mammal burrows and one small mammal burrow cluster (Figure 1), could provide upland refugia habitat for the state- and federally listed as threatened California tiger salamander (*Ambystoma californiense*) and the western spadefoot (*Spea hammondi*), a California Species of Special Concern. The low-flow channels of the San Joaquin River (Figure 7), which were approximately 25–250 feet west of Lost Lake Trail, provide habitat for the state- and federally listed as threatened Central Valley spring-run Chinook salmon (*Onchorynchus tshawytscha*) and two California Species of Special Concern, hardhead (*Mylopharodon conocephalus*) and western pond turtle (*Actinemys marmorata*). The biological survey area and surrounding buffers supported numerous potential nest trees for Swainson's hawk, bald eagle, white-tailed kite, and other birds. Thirty-four bird species, four mammal species, and two reptile species were detected during the survey (Table 2). No special-status plants or animals were found.

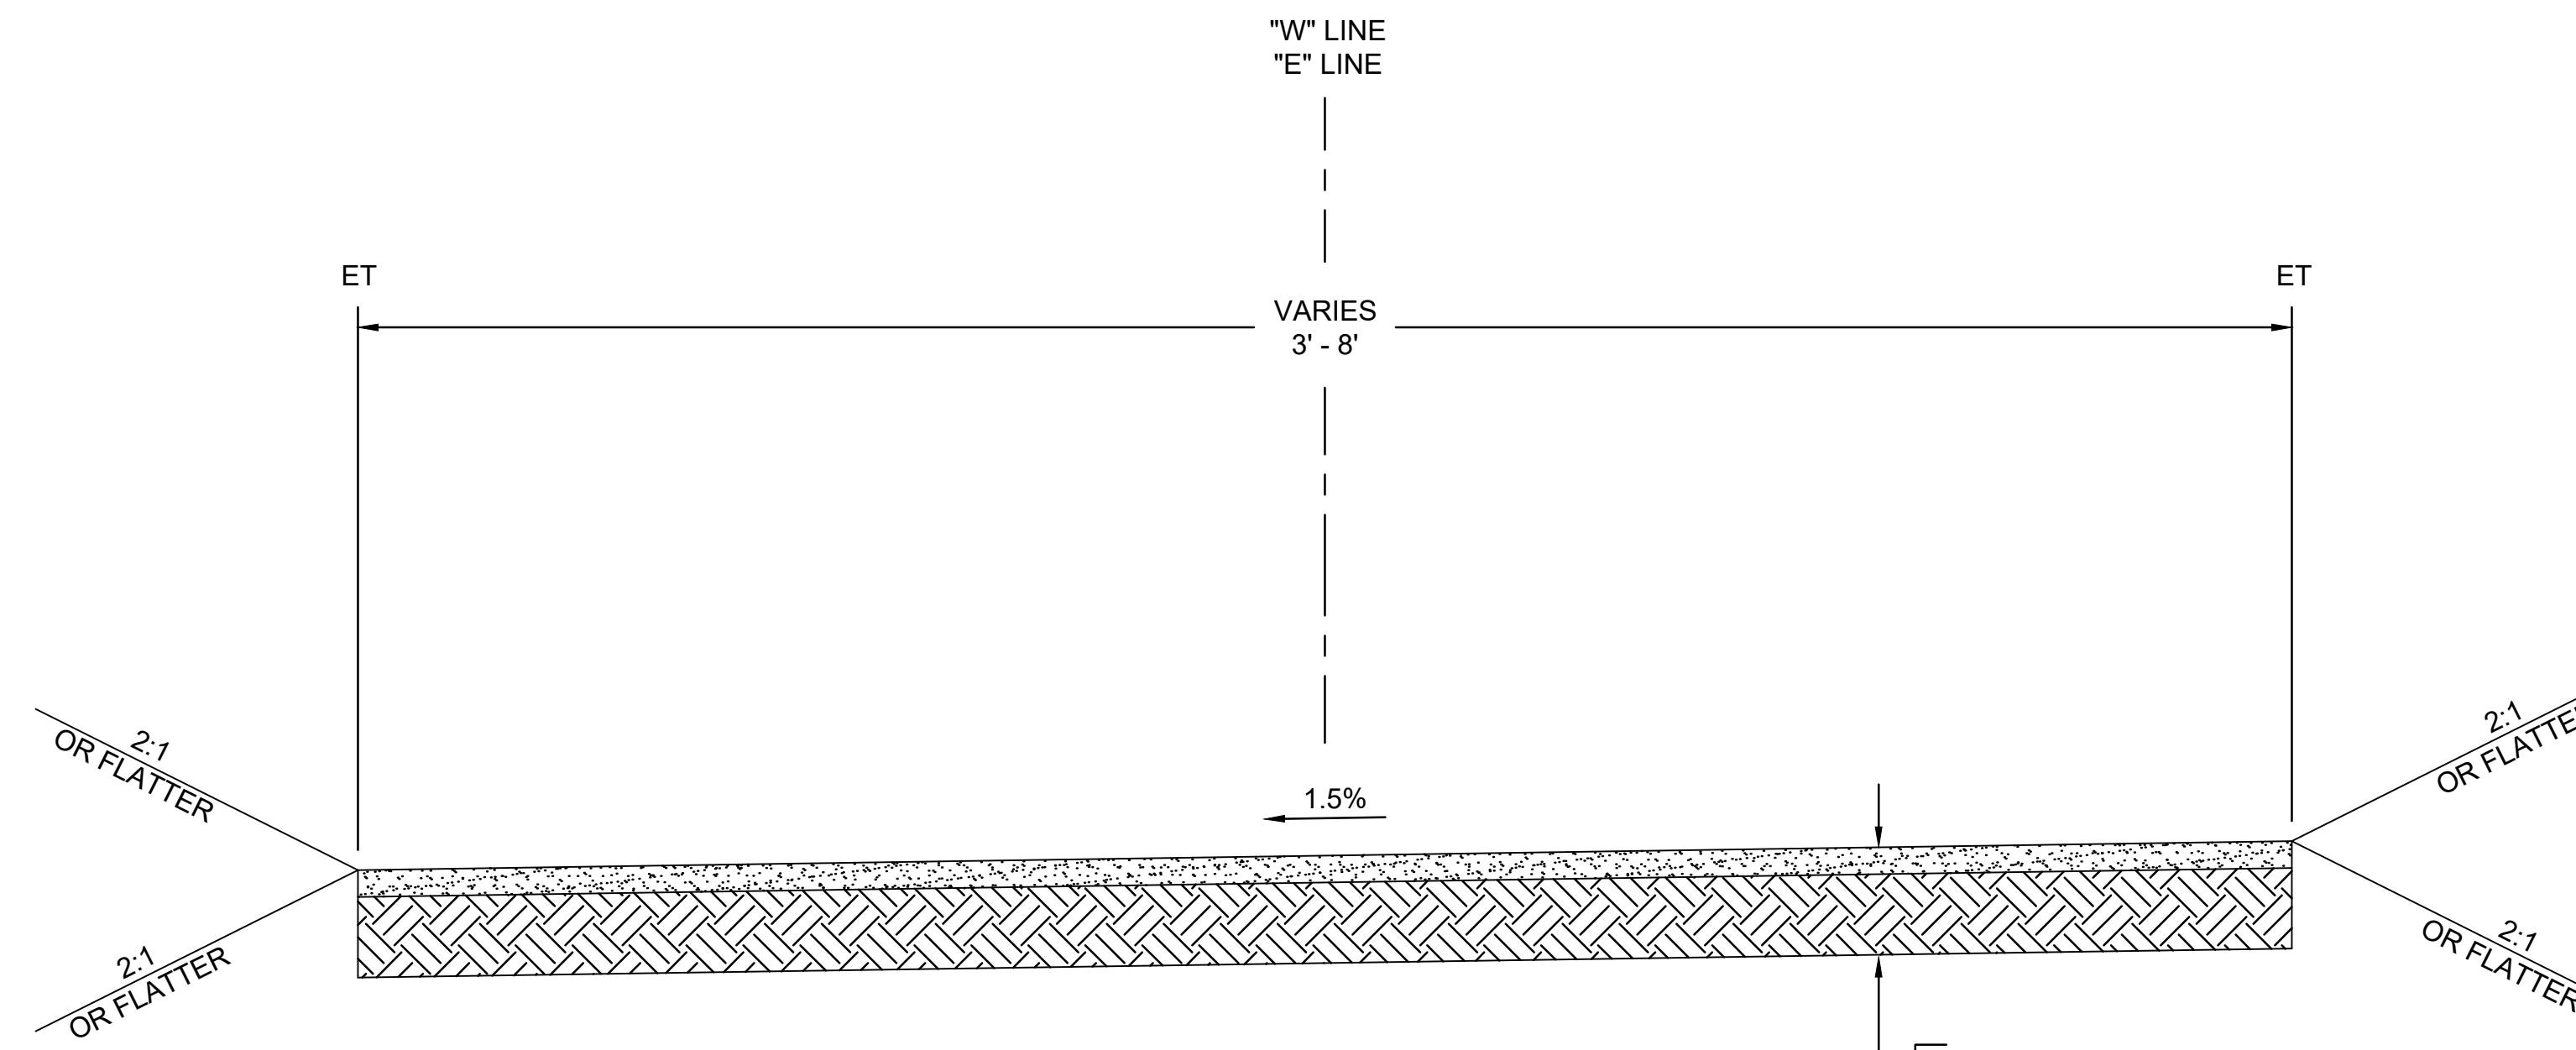
TYPICAL SECTION

LOST LAKE TRAIL
 STA "W" 10+00 TO 11+61.58
 STA "W" 18+32.05 TO 22+00.79
 STA "W" 23+68.25 TO 24+44.12
 STA "E" 52+02.09 TO 55+59.95

0.17' DG
 0.50' 95% COMPACTED NATIVE SOIL

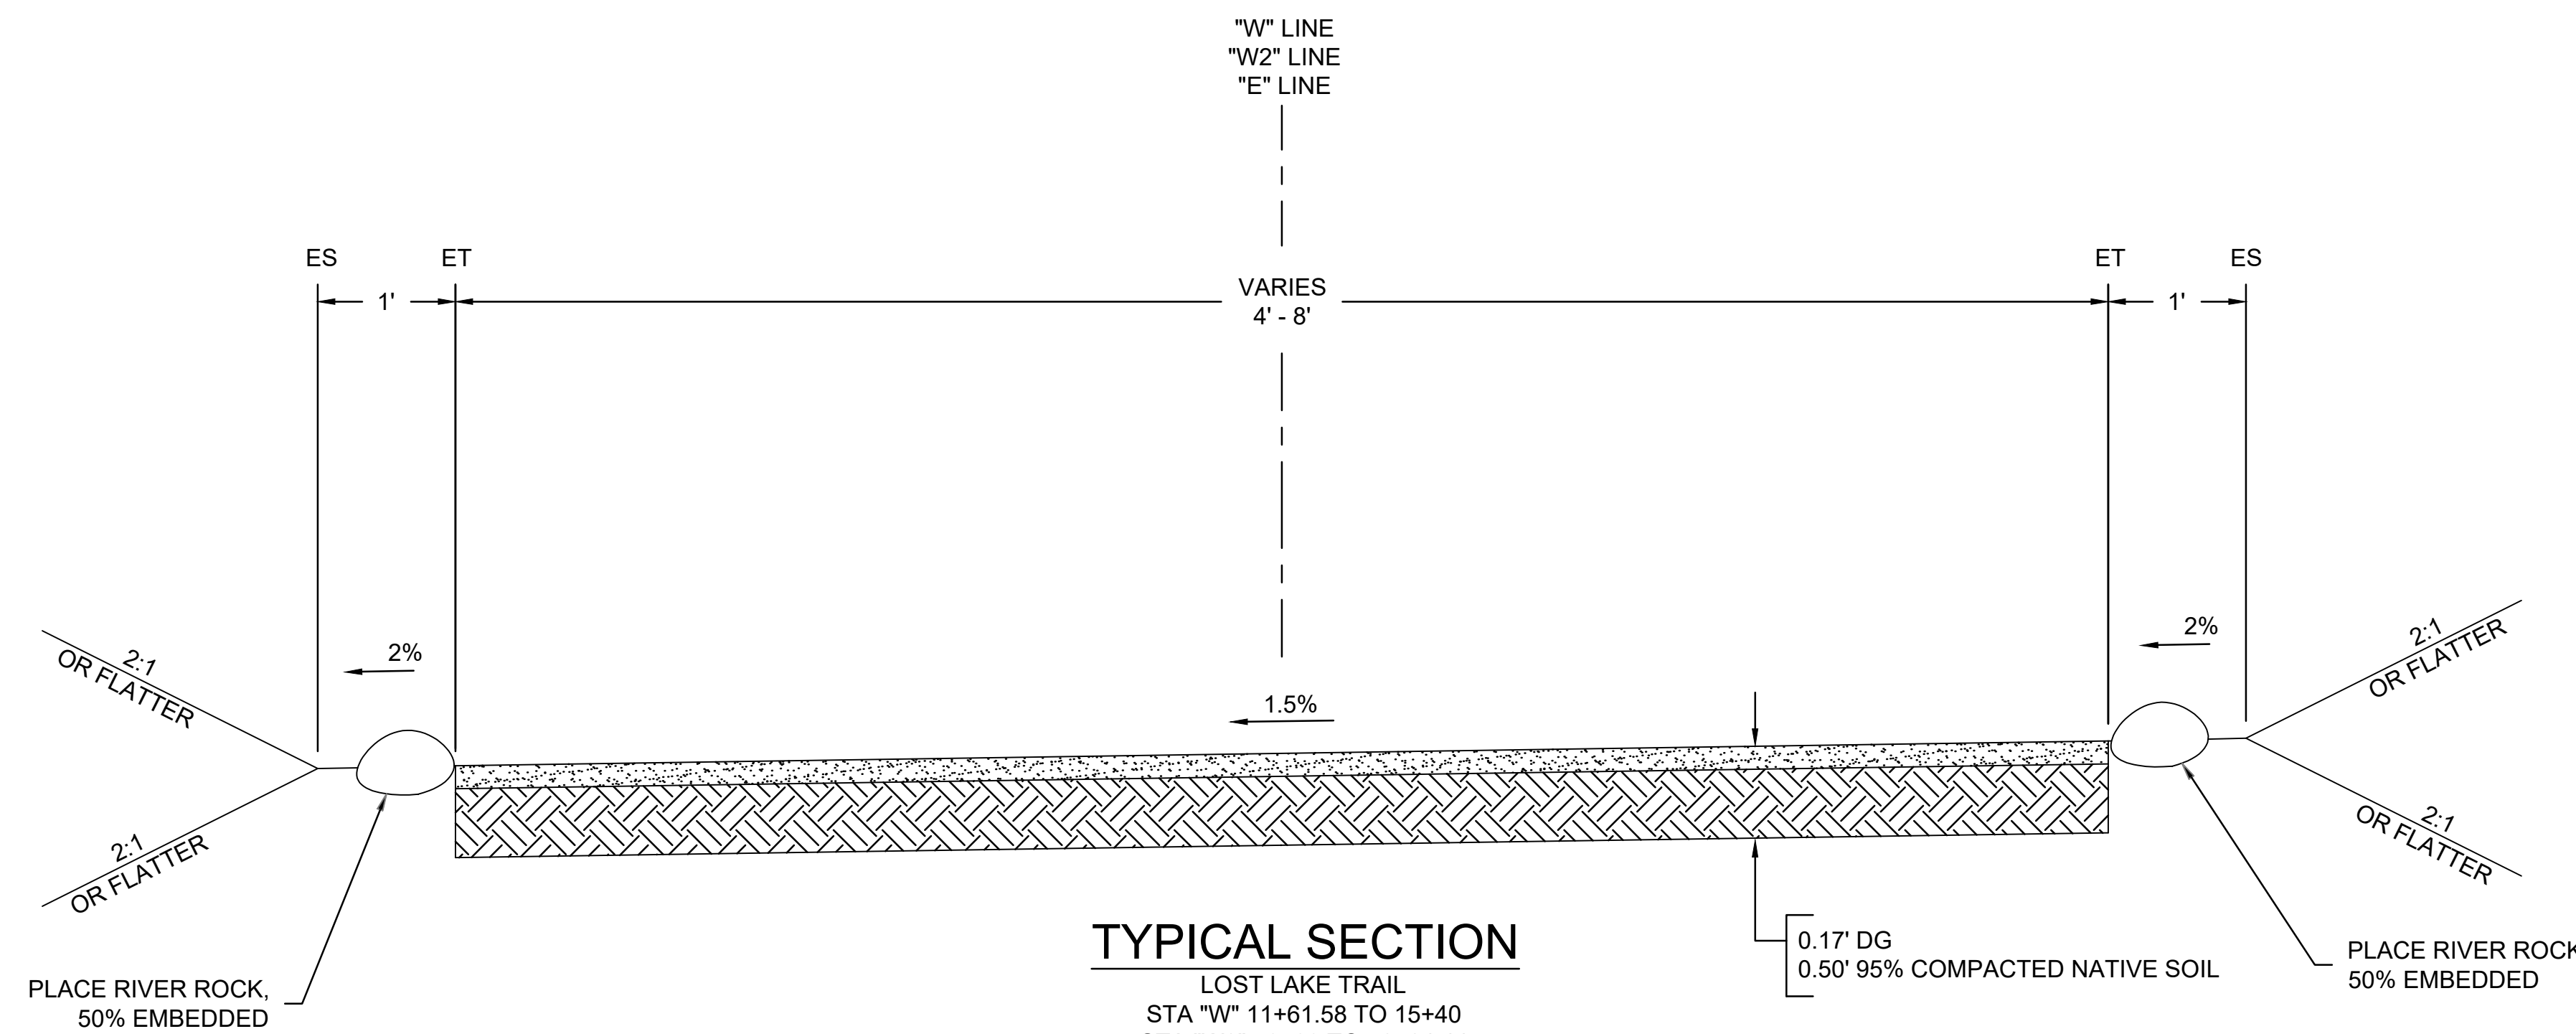
TYPICAL SECTION

LOST LAKE TRAIL
 STA "W" 11+61.58 TO 15+40
 STA "W2" 70+00 TO 72+24.44
 STA "W" 17+59.78 TO 18+32.05
 STA "W" 22+00.79 TO 23+68.25
 STA "W" 24+44.12 TO 28+95.74
 STA "E" 50+00 TO 52+02.09
 STA "E" 55+59.95 TO 57+94.15

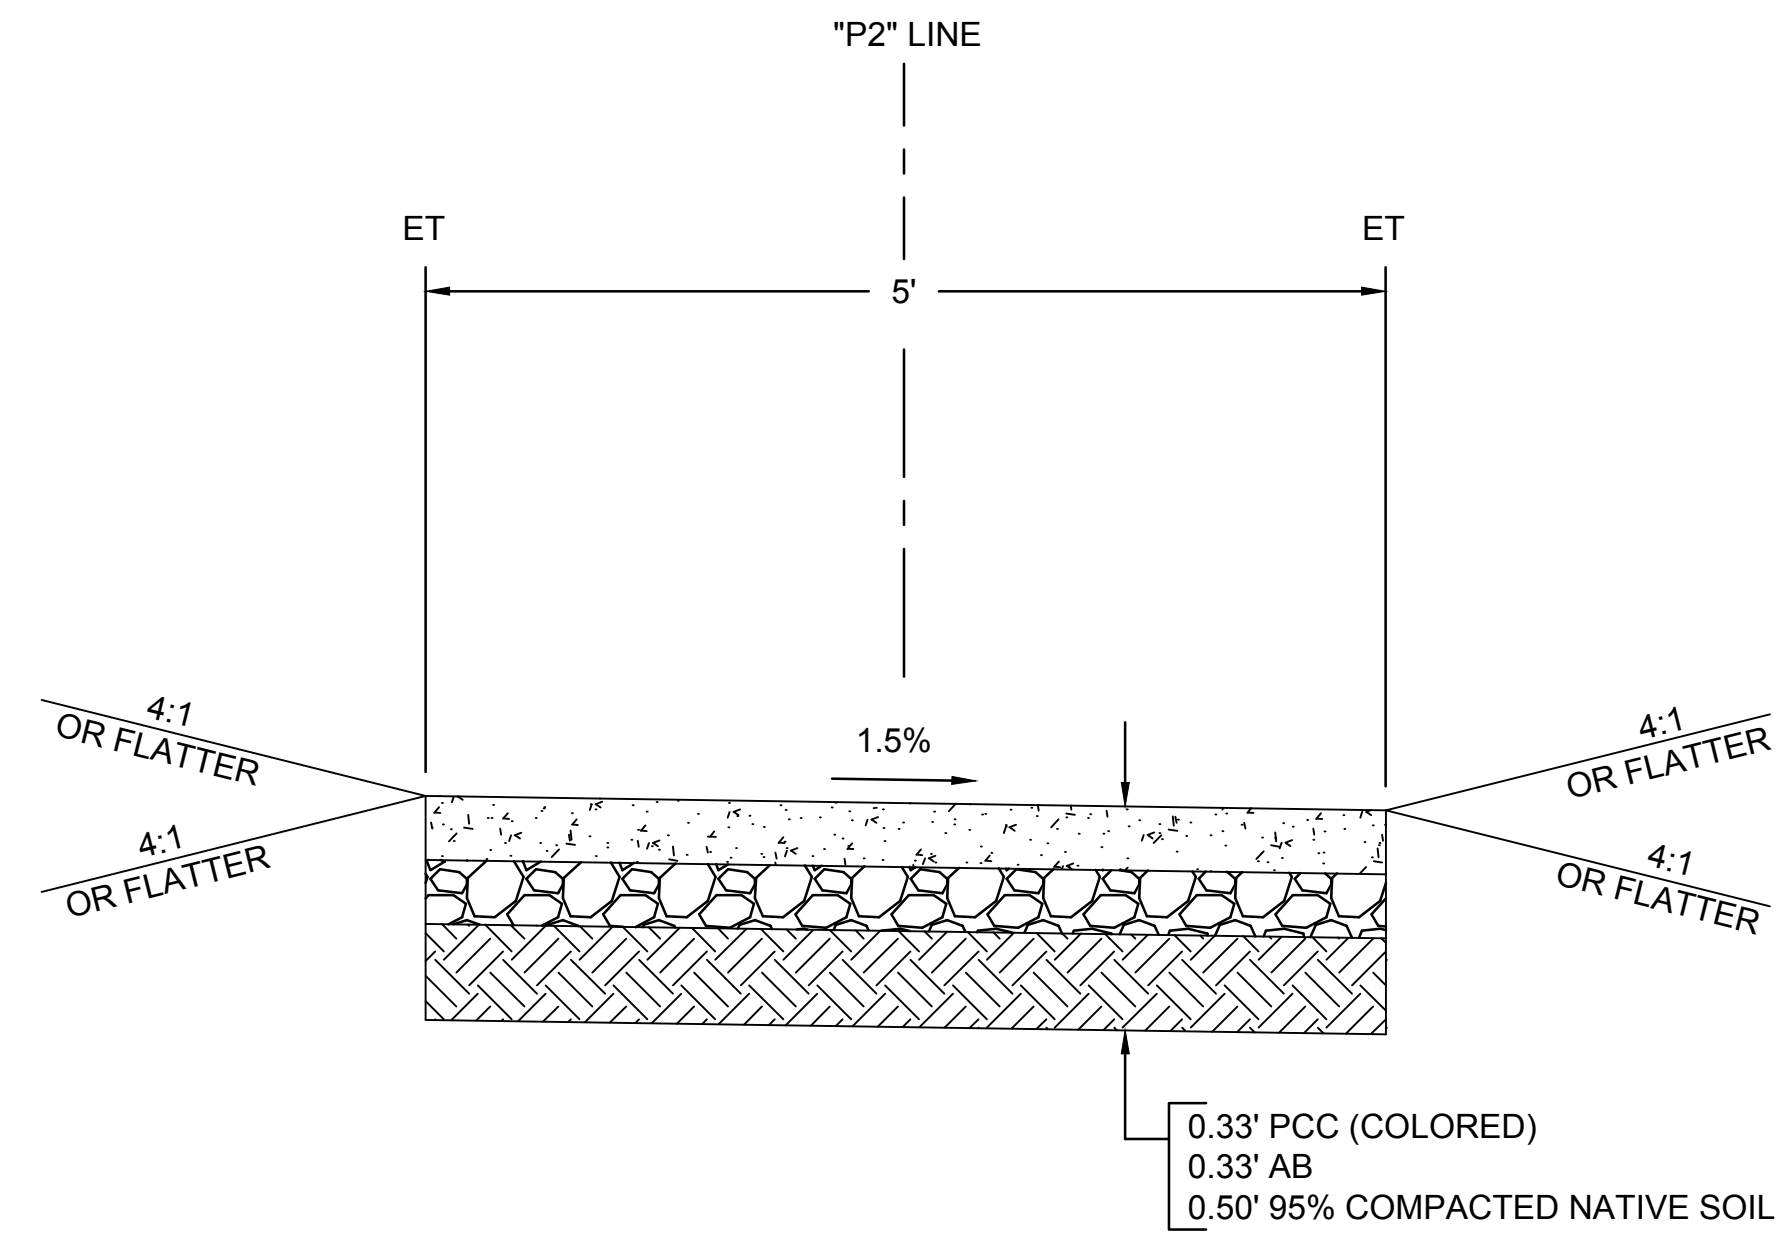
TYPICAL SECTION
WALKWAY 2
STA "P2" 50+02.50 TO 50+68.22

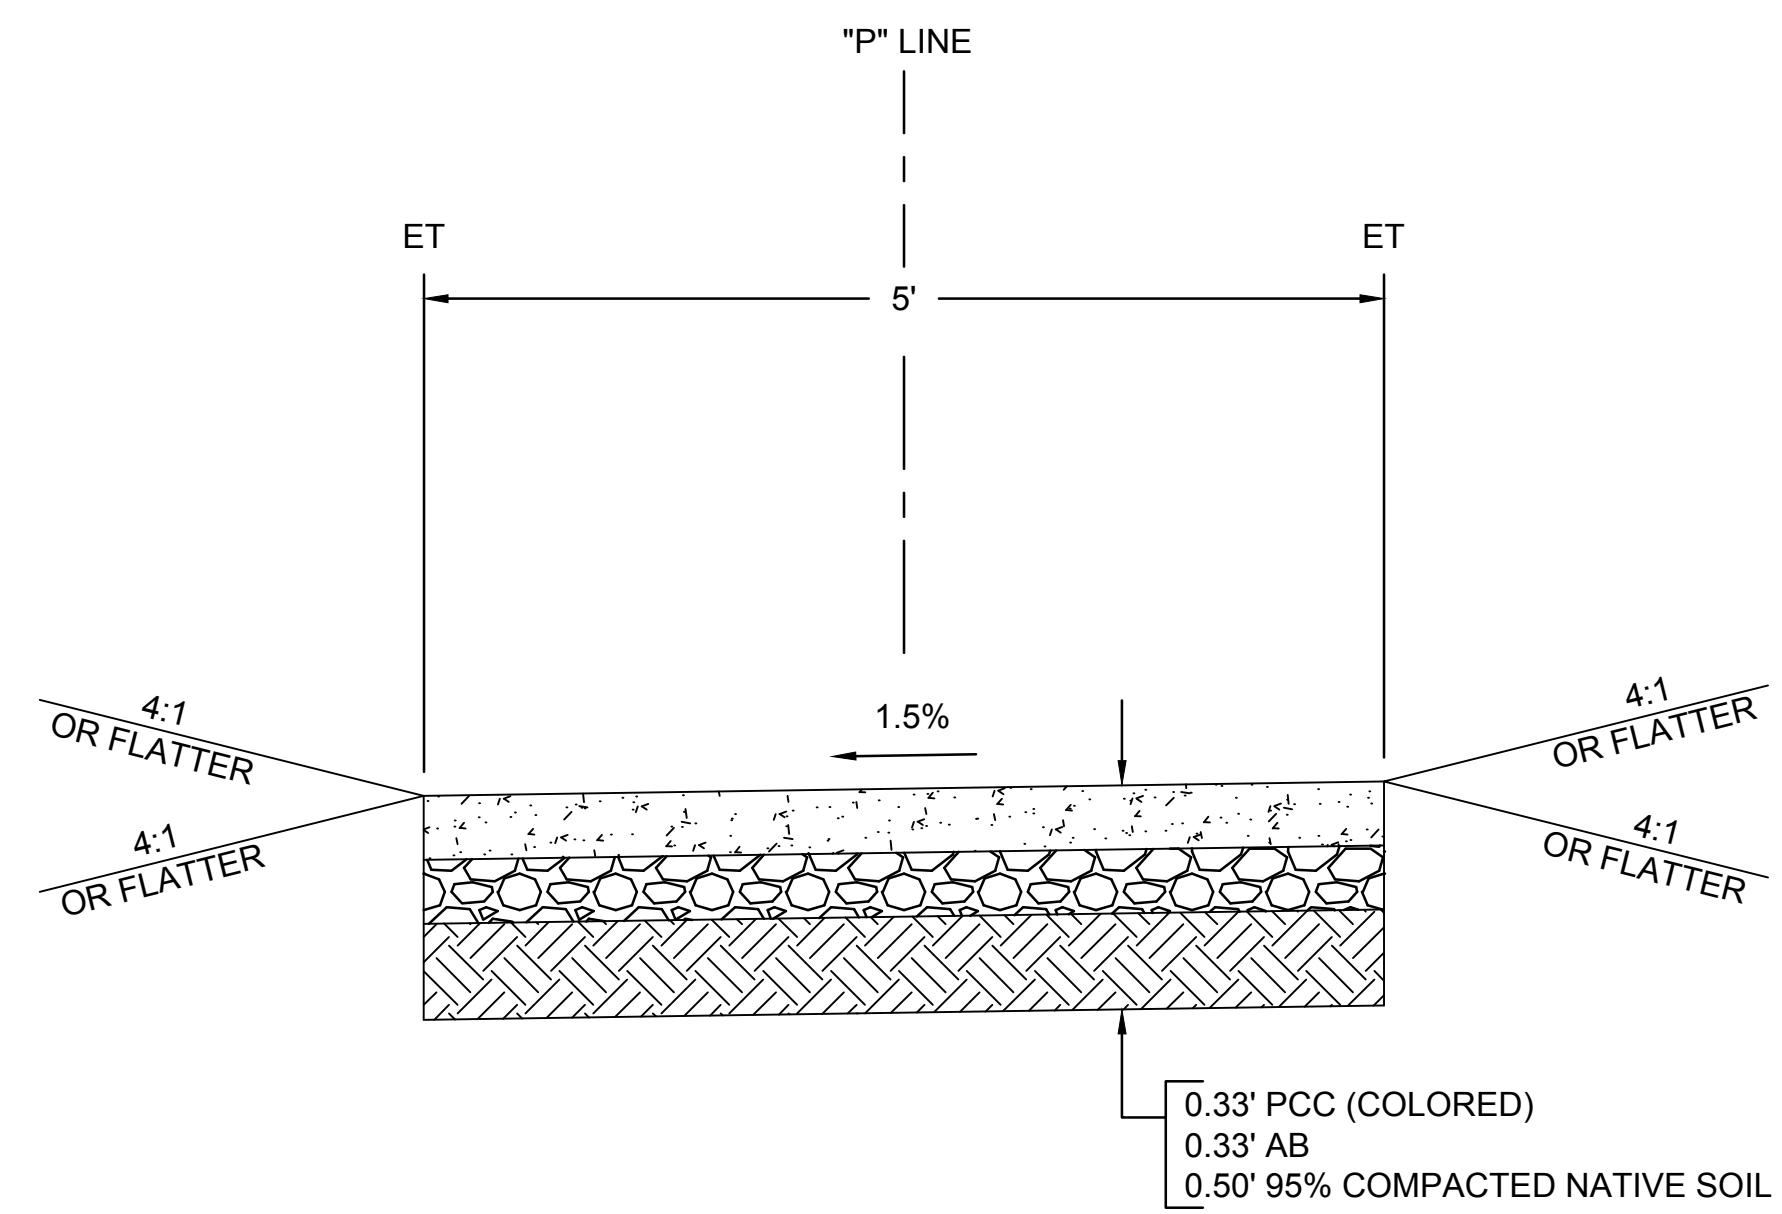
TYPICAL SECTION
WALKWAY
STA "P" 5+00 TO 6+50

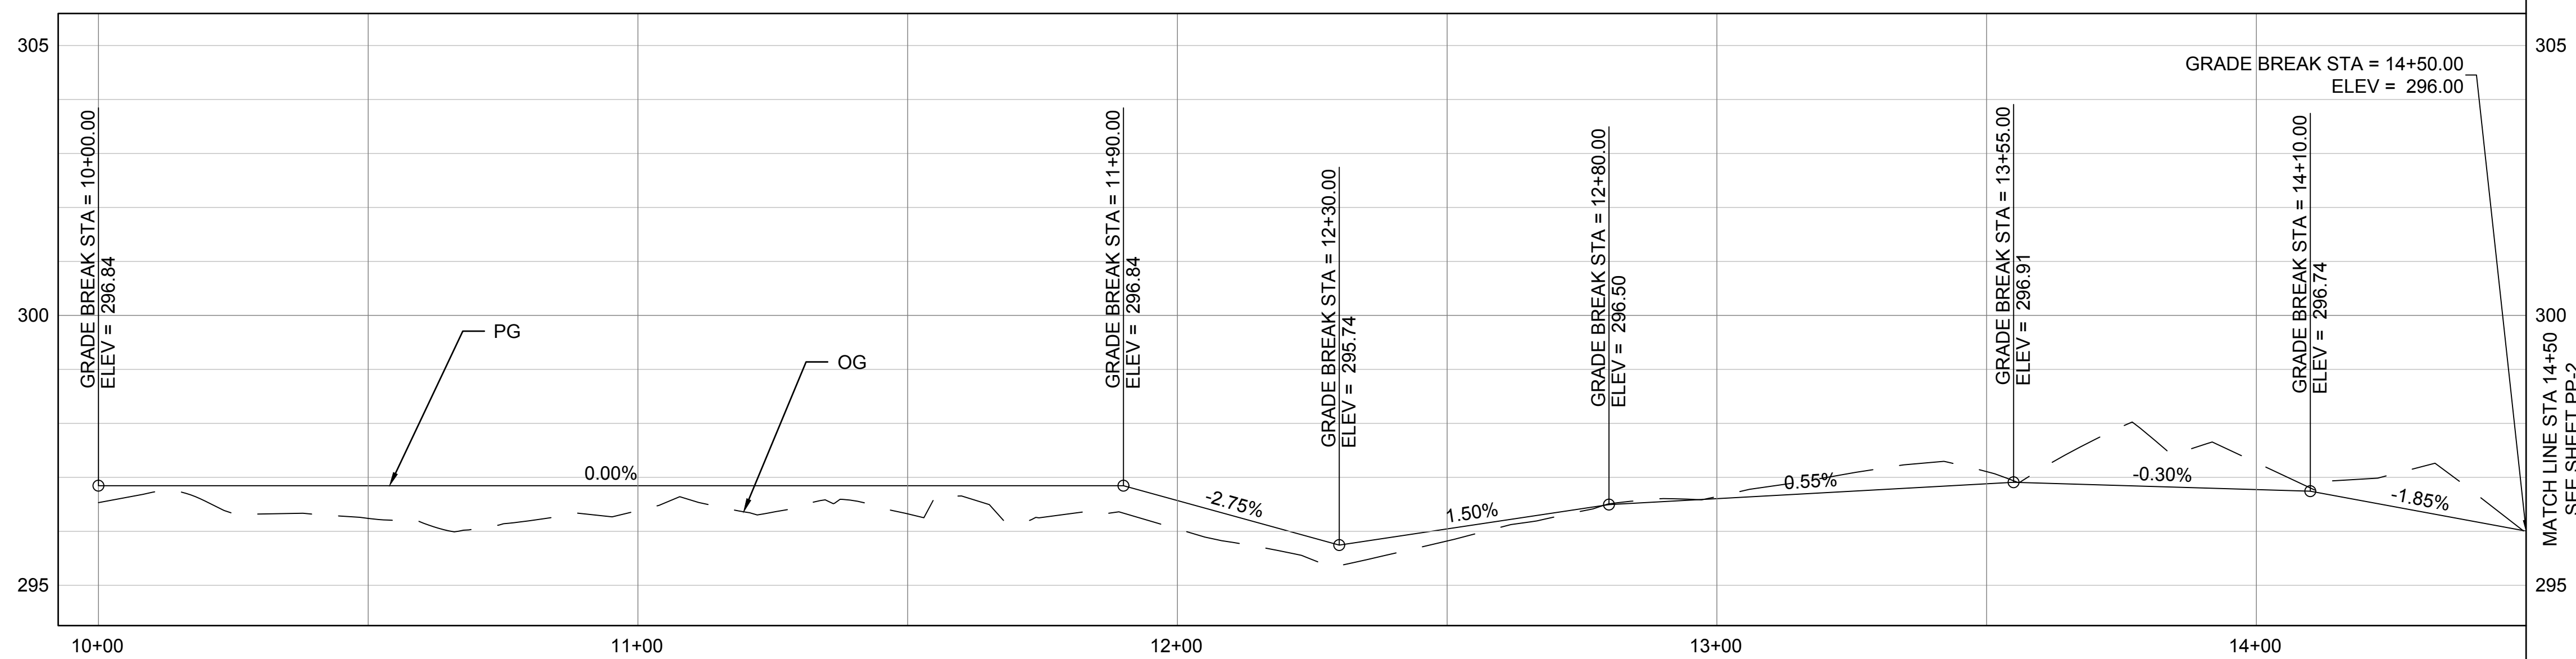
"W" LINE PROFILE
 HORIZONTAL SCALE: 1" = 20'
 VERTICAL SCALE: 1" = 2'

- NOTES:
- EXISTING CONTOURS AND ELEVATIONS ARE BASED ON TOPOGRAPHIC SURVEY PERFORMED IN AUGUST, 2016. SITE CONDITIONS MAY HAVE CHANGED SINCE THAT TIME. THE CONTRACTOR SHALL VERIFY ELEVATIONS AND MAY ADJUST THE FINISHED GRADE ELEVATIONS UP TO ±0.2 FEET, AS APPROVED BY THE ENGINEER TO COMPENSATE FOR MINOR GRADE VARIATIONS.
 - STATION OFFSETS FOR RIVER ROCKS REFER TO EDGE OF TRAIL.
 - VERIFY TREES TO BE TRIMMED WITH RESIDENT ENGINEER.

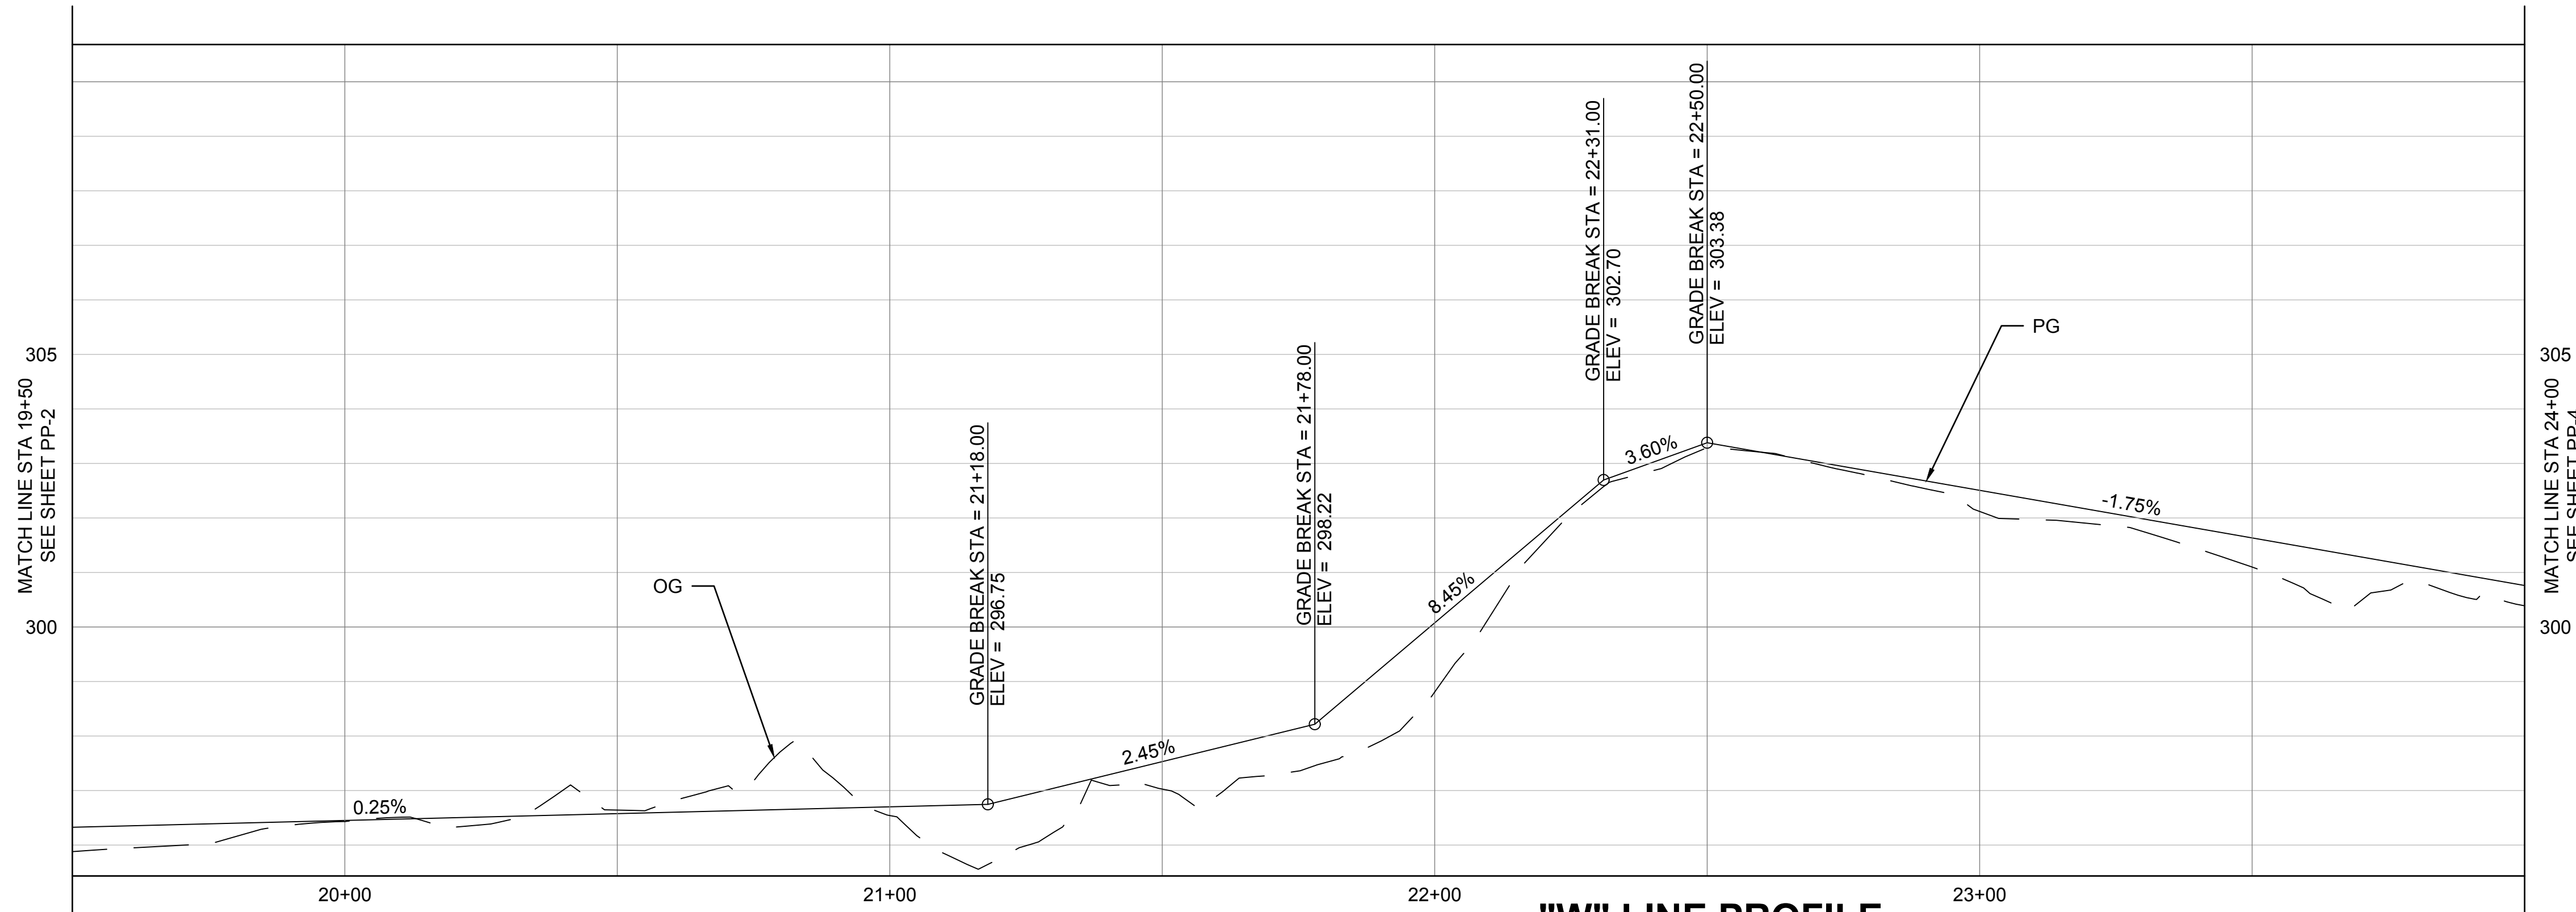
"W" LINE PROFILE
HORIZONTAL SCALE: 1" = 20'
VERTICAL SCALE: 1" = 2'

- NOTES:
- EXISTING CONTOURS AND ELEVATIONS ARE BASED ON TOPOGRAPHIC SURVEY PERFORMED IN AUGUST, 2016. SITE CONDITIONS MAY HAVE CHANGED SINCE THAT TIME. THE CONTRACTOR SHALL VERIFY ELEVATIONS AND MAY ADJUST THE FINISHED GRADE ELEVATIONS UP TO ±0.2 FEET, AS APPROVED BY THE ENGINEER TO COMPENSATE FOR MINOR GRADE VARIATIONS.
 - STATION OFFSETS FOR RIVER ROCKS REFER TO EDGE OF TRAIL.
 - VERIFY TREES TO BE TRIMMED WITH RESIDENT ENGINEER.

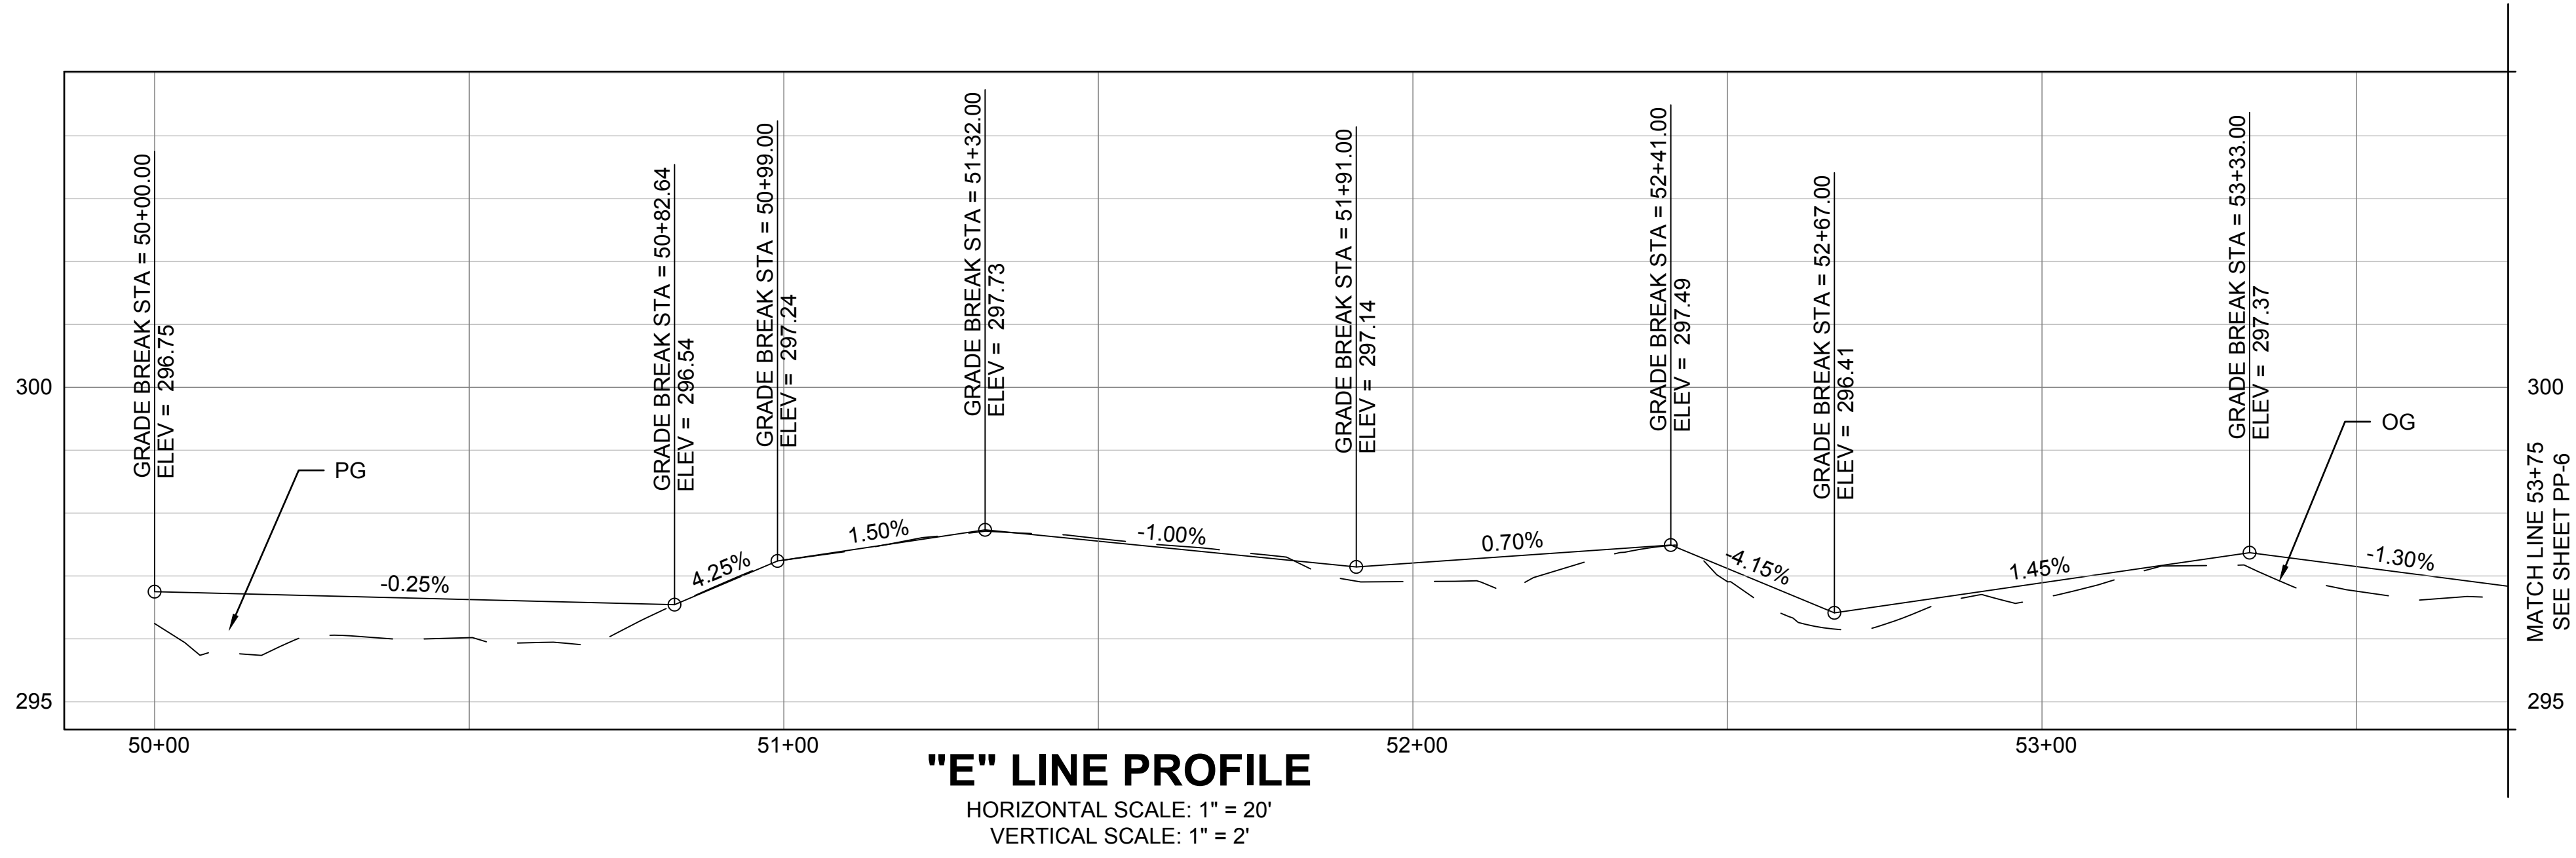
"E" LINE PROFILE
HORIZONTAL SCALE: 1" = 20'
VERTICAL SCALE: 1" = 2'

- NOTES:
- EXISTING CONTOURS AND ELEVATIONS ARE BASED ON TOPOGRAPHIC SURVEY PERFORMED IN AUGUST, 2016. SITE CONDITIONS MAY HAVE CHANGED SINCE THAT TIME. THE CONTRACTOR SHALL VERIFY ELEVATIONS AND MAY ADJUST THE FINISHED GRADE ELEVATIONS UP TO ±0.2 FEET, AS APPROVED BY THE ENGINEER TO COMPENSATE FOR MINOR GRADE VARIATIONS.
 - STATION OFFSETS FOR RIVER ROCKS REFER TO EDGE OF TRAIL.
 - VERIFY TREES TO BE TRIMMED WITH RESIDENT ENGINEER.
 - SEE SHEETS PP-1 TO PP-4 FOR "W" LINE DETAILS
