County of Fresno

The Department of Public Works and Planning, Development Services and Capital Projects Division is reviewing the subject application proposing to replace the Little Dry Creek Bridge with a new bridge consisting of two 12-foot wide lanes and two 4-foot wide shoulders within right-of-way located along Millerton Road, approximately 3.93 miles east of Auberry Road.

Fresno County (County) Department of Public Works and Planning proposes to replace a bridge on Little Dry Creek (42C0270) in the north central portion of Fresno County on Millerton Road between Auberry Road to the west and State Route 168 to the east. This stretch of Millerton Road is a local rural street with an average daily traffic (ADT) count of approximately 400. The projected future ADT (Year 2035) is approximately 850. Bicyclist and bike organizations also use this potion of Millerton Road as a bike route.

LITTLE DRY CREEK BRIDGES REPLACEMENT ON MILLERTON ROAD

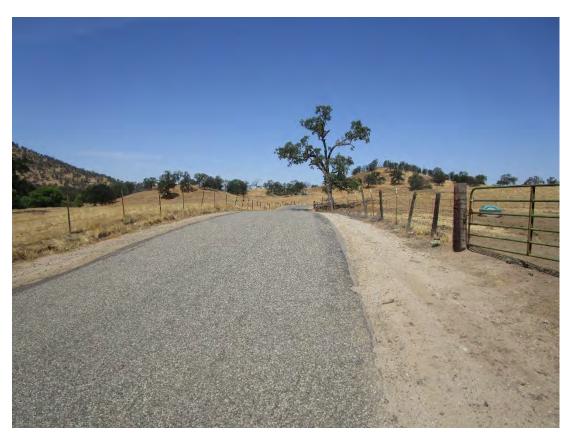
Figure 1 – View of roadway approach away from Bridge No. 42C0270 facing west.

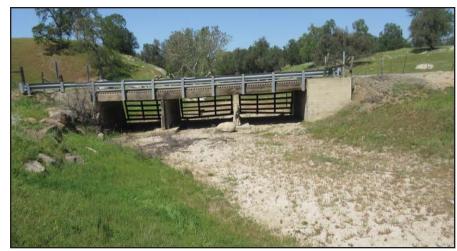
Little Dry Creek Bridges Replacement on Millerton Road Representative Photos (1)

Looking at bridge No. 269 from the south.

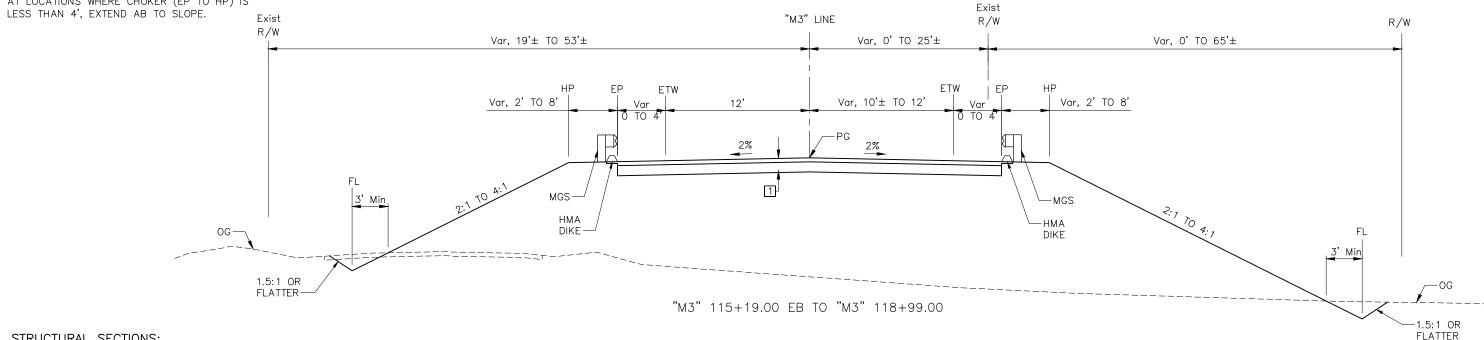
STRUCTURAL SECTIONS:

0.33' HMA (TYPE B) 0.50' CLASS 2 AGGREGATE BASE

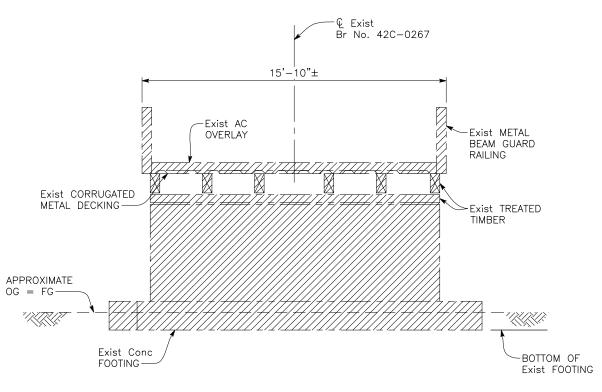
EXISTING ABUTMENTS AND PIERS

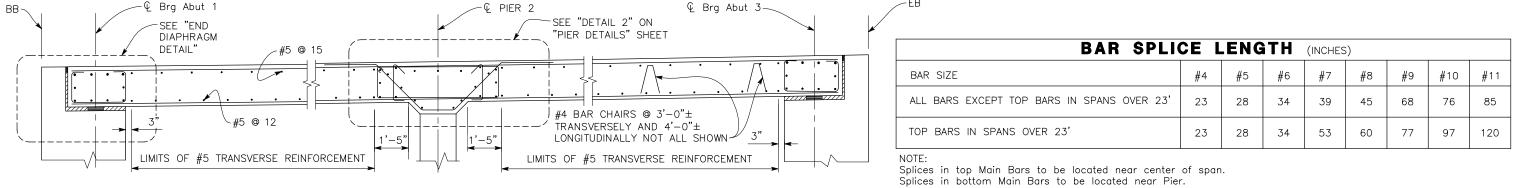
LONGITUDINAL SECTION

- @ PIER 2

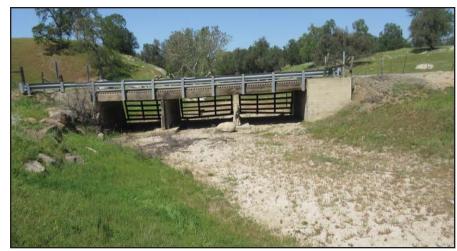
Little Dry Creek Bridges Replacement on Millerton Road Representative Photos (1)

Looking at bridge No. 269 from the south.

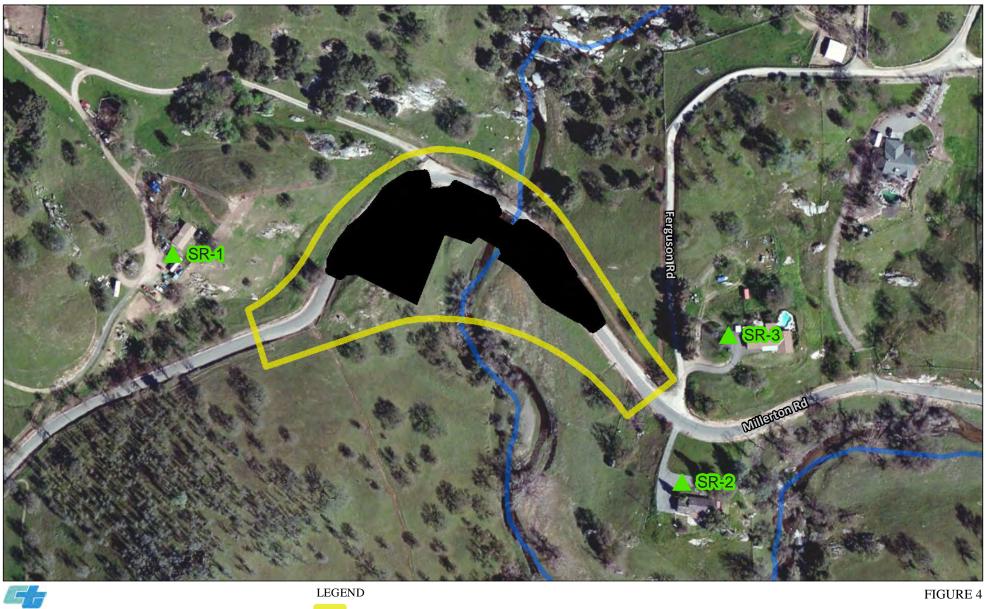
PROJECT SITE AND DESIGN OF BRIDGE NO. 42C0267

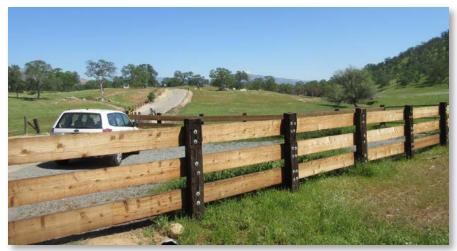
Bridge No. 42C0269 facing east from the turnout immediately before the bridge and looking east along Millerton Road.
